Grupo de Saneamento de Bilibiza

Water for Bilibiza

Production & Training Centre for Low Cost WASH Solutions L14004

FINAL NARRATIVE REPORT
January to December 2016

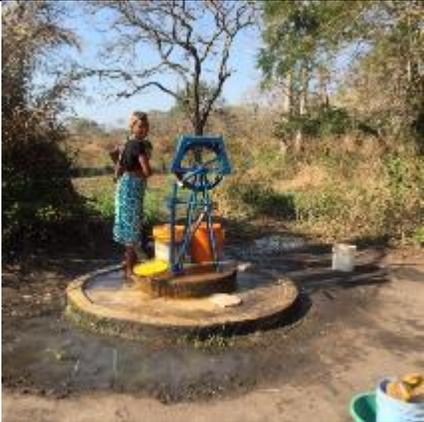
Pump Nr.	Name of owner or caretaker	Total nr of users	Images
Natuco Village			
1.	Farmers' club Water Committee	50 farmers and families

In some places it was not possible to make drilled tube wells due to the ground conditions, for instance in in the primary schools Natuco there were 3 negative holes. Therefore in Natuco 5 wells were drilled and in Muaja1 for the farmers' club. Two of the wells from Natuco are not operational due to the lack of water in the ground:

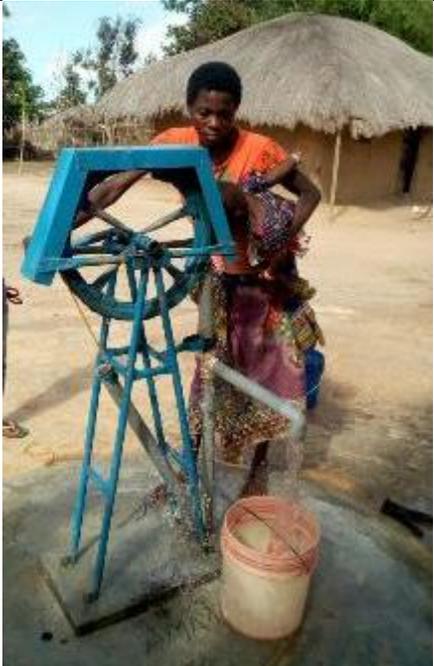
A woman in a colorful patterned dress is operating a blue manual water pump. She is turning the large blue wheel, and water is being dispensed into a white bucket. In the background, there is a traditional thatched-roof hut.
4.	Mr. Jorge Mitilage	150 users

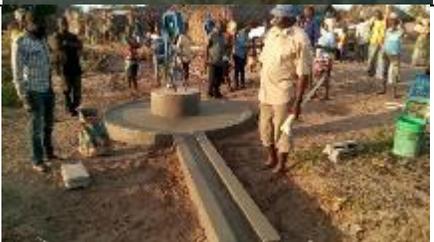
A group of people, including men, women, and children, are gathered around a public water pump. Some are standing near the pump, while others are further back. The pump is a circular concrete structure with a central well.

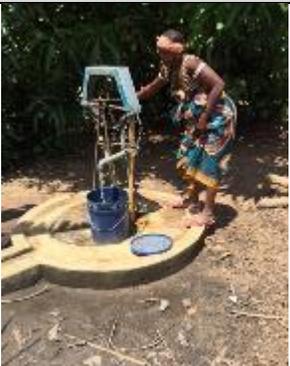
Muaja Village			
6.	Farmers' club Water Committee	50 families

Table 2: Data of pumps installed on tube wells in Natuco and Muaja

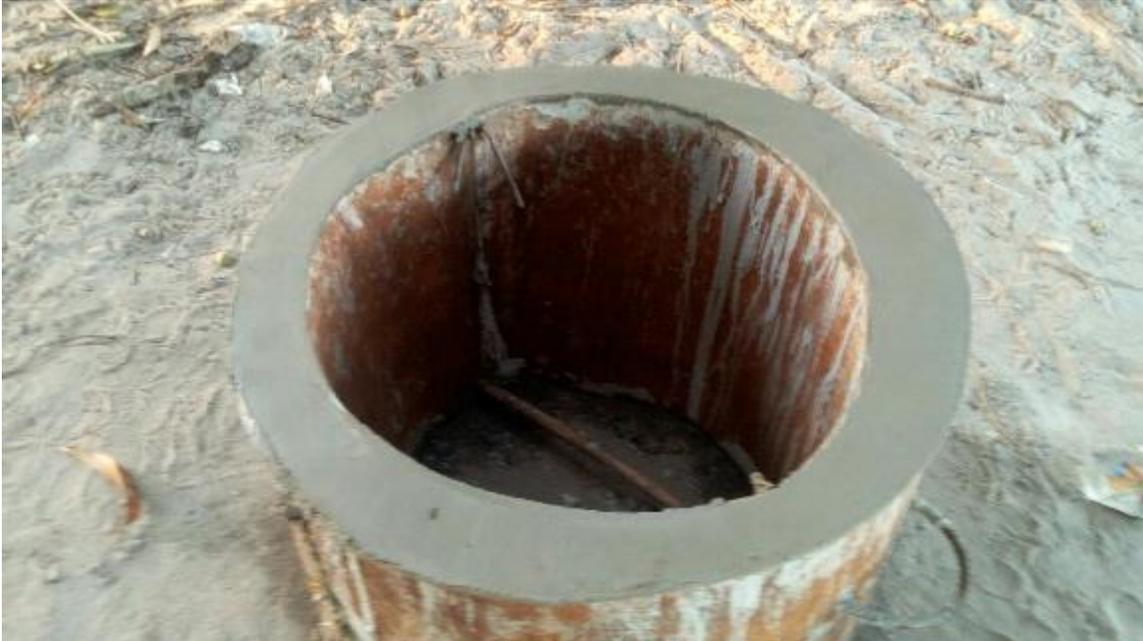
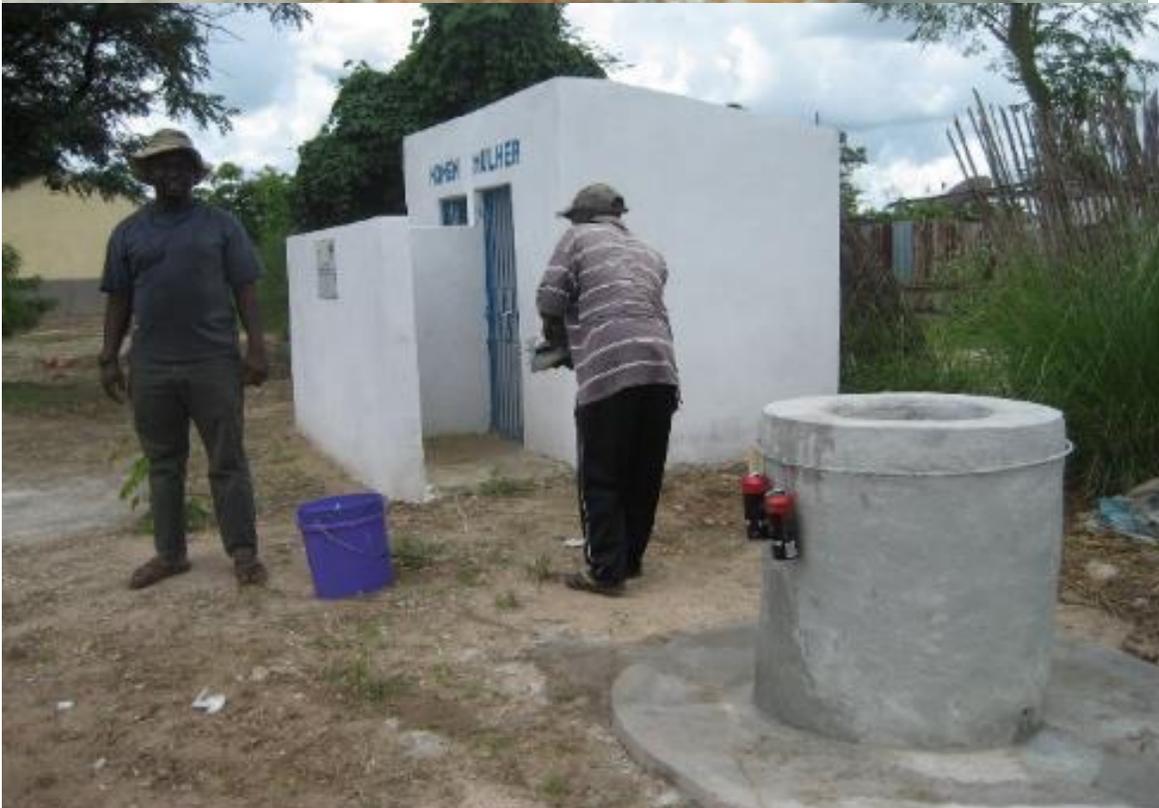
Table 3: Hand washing tank in the Primary School of Montepuez

In the beginning of the year the Primary School of Montepuez has benefited from the construction of a water tank for hand washing, this is a SMARTech that has been tested in the school. When it was first handed to the school it was not cleaned regularly, but now it is operational and the only problem was that children steal the cups that are put there. A solution now is to use a strong metal cup with a long handle and holes in the bottom so it cannot be used for other things than handwashing.

The school wash tank made in February 2016 is working. However the cups that are hanging on the rim were taken away by children

Now a cup with a long handle is used and kept inside during the night.

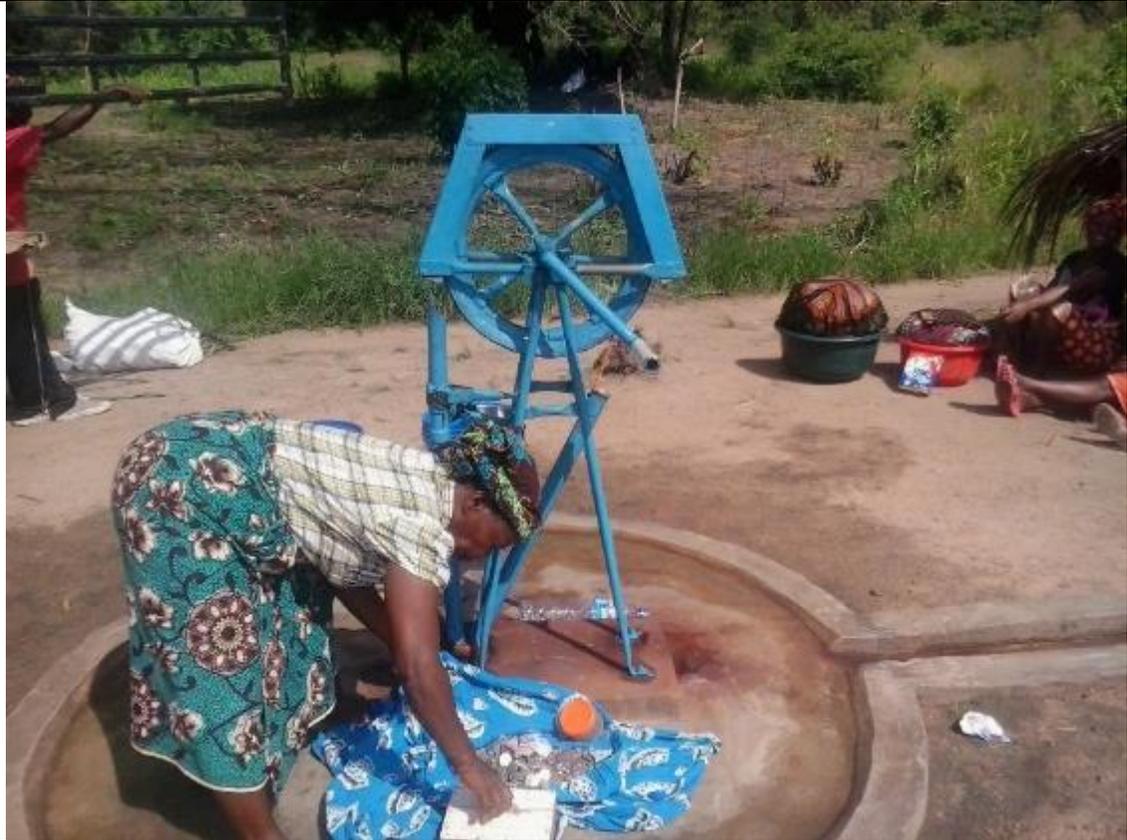
Figure 5: Mrs. Teresa an example of the FLOM approach

One of the Rope pump owners visited by H. Holtslag is the pump pf Mrs. Teresa. She is the pump cate taker and manages the pump. Daily some 200 people or more use water from this pump and pay a few cents per bucket. This payment gives income for Mrs. Teresa and gives funds for repairs. Despite the intensive use of the pump, this pump is in very good order because it is well maintained. Because of the good experiences GSB uses this example of FLOM (Family Level Operation and Maintenance) as a maintenance model example for pumps to be installed for communal water supply in rural areas.

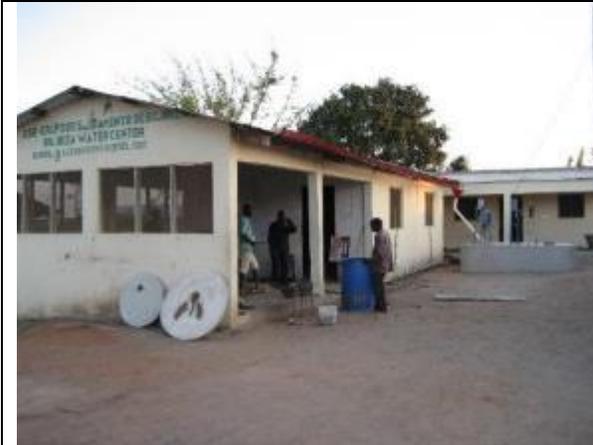
The GSB SMART Centre in Bilibiza. Workshop plus office. Note the new rainwater harvesting tank

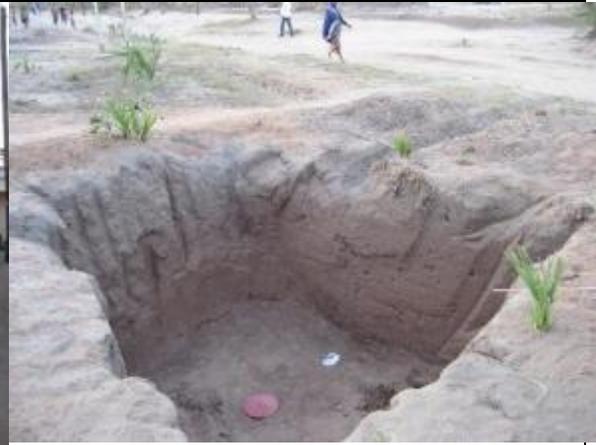
To capture rain water and infiltrate it in the ground, GSB made a large Tube recharge system of 8000 liter near the workshop

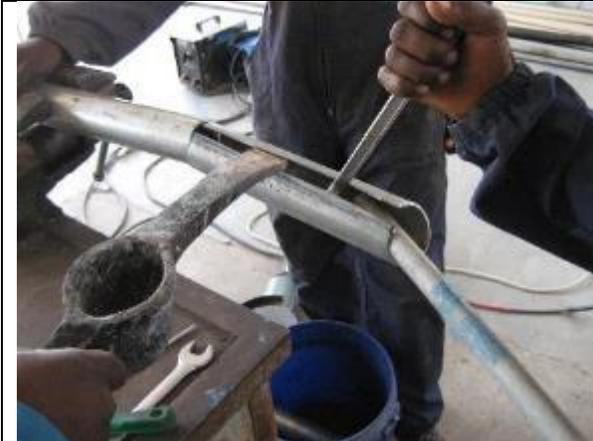
During the visit some technologies were improved like the Soil punch to make wells

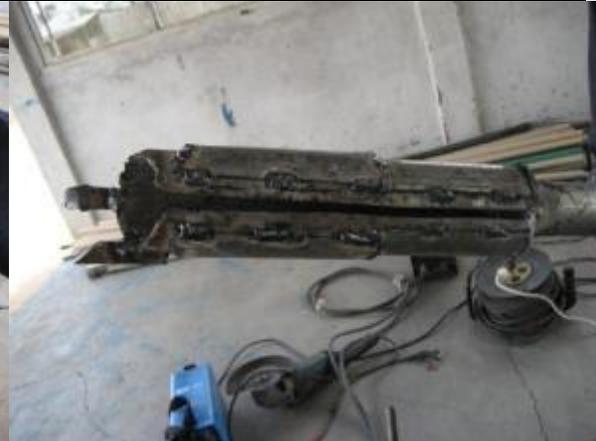
The Soil punch was reinforced to reduced breakage

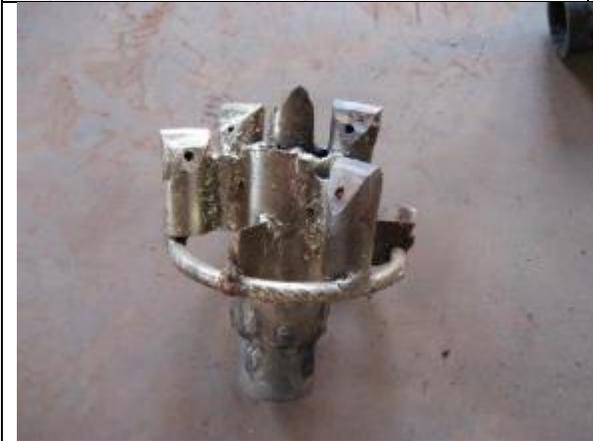
A new drill bit for the SHIPO drill system with Tungsten bits.

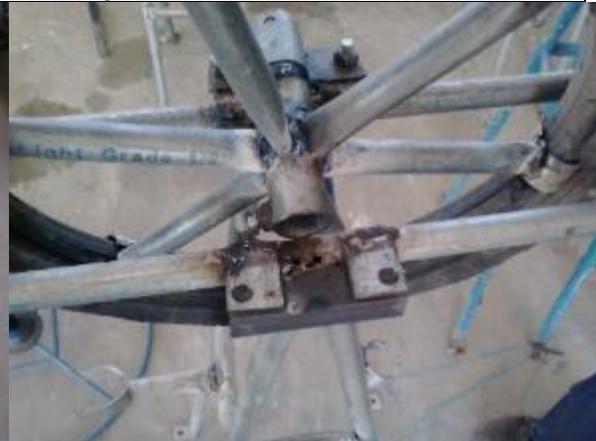
Still some problems in the production of Rope pumps but quality is improving

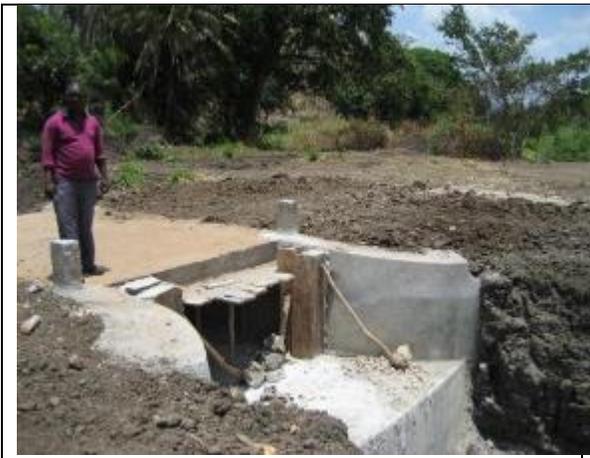
This is one of the two large 80 m long dams made by GSB to create a large artificial lake. This work was funded by the Japanese embassy

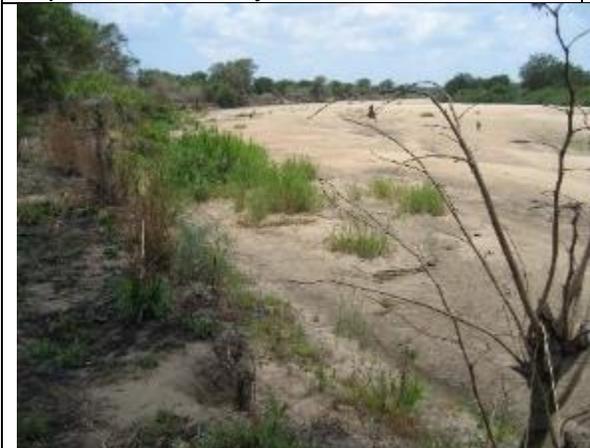
The River along Bilibiza that was full in February is now completely dry

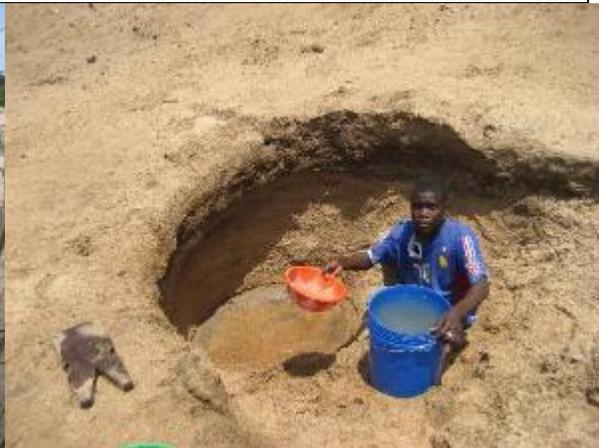
Families from Bilibiza still find some water in so called scoop holes in the river

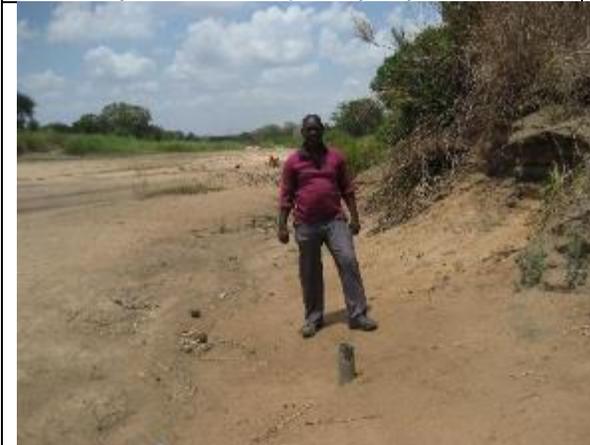
Bachir standing at one of the 7 Rope pumps that were completely washed away by the huge floods in 2015

The floods and draughts are cyclical in Mozambique. Floods contribute to wash away rope pumps installed on drilled tube wells and some of the materials of other parts of the wells are lost in the process. For Natuco specifically it took long for GSB to find positive holes due to the soil conditions, therefore the strategy was to include water recharge systems near the positive holes, preventing the wells from drying. But the thing with the water recharge systems is that the beneficiaries do not do the maintenance on the tubes after rain fall. Then the tubes gets full of sand and the water recharge systems do not work and the drilled tube well dries. This leads to the next constraint GSB is facing in some areas, lack of beneficiaries commitment;

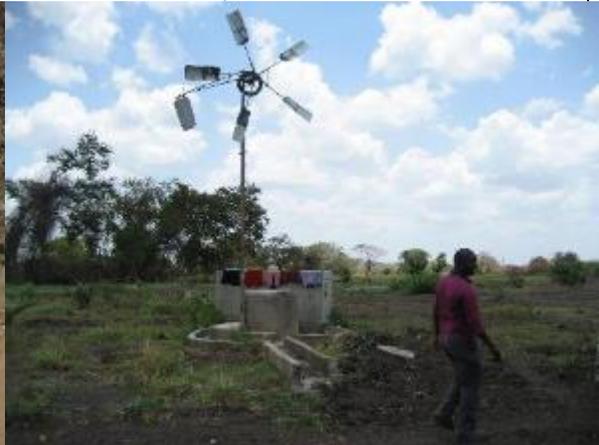
GSB is planning to repair the Wind mill (wind rope pump) installed in Bilibiza in 2006

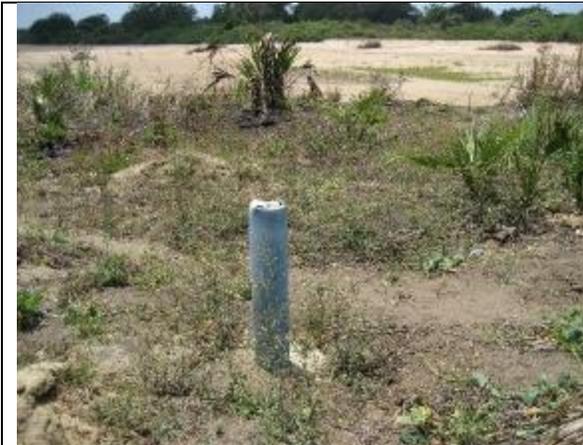
A machine drilled borehole near the Rope pump. The depth is 60 meters but the water at that depth is salt!!! This is part of a 0.5 mln \$ project for piped water in Bilibiza.

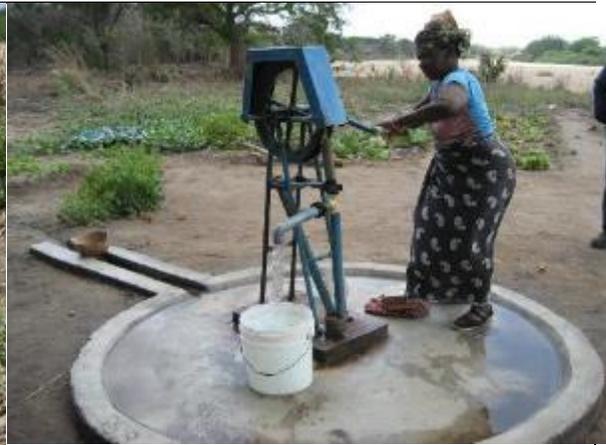
The pump of Mrs. Teresa is OK. The FLOM model works. She sells water at 2 Cents/bucket). This is for pump repairs, some income and she saves money for a new pump.

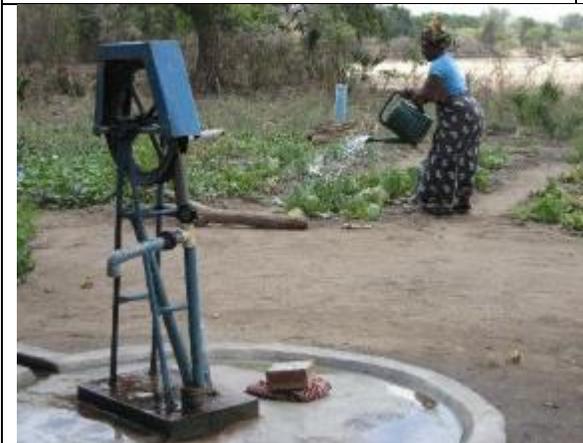
She also made a small garden near the pump and sold vegetables in the last 4 months. She now has money for a 2nd well and pump
